**U.S. NAVAL BASE, PEARL HARBOR, BAKER DOCKS B-11 TO B-21  
(U.S. Naval Base, Pearl Harbor, Naval Station)  
(Wharfs, Bravo Docks B-11 to B-21)  
North of Pearl Harbor Shipyard  
Pearl Harbor  
Honolulu County  
Hawaii**

**HAER No. HI-10**

**HISTORIC AMERICAN ENGINEERING RECORD  
U.S. Department of the Interior  
National Park Service  
Oakland, California**

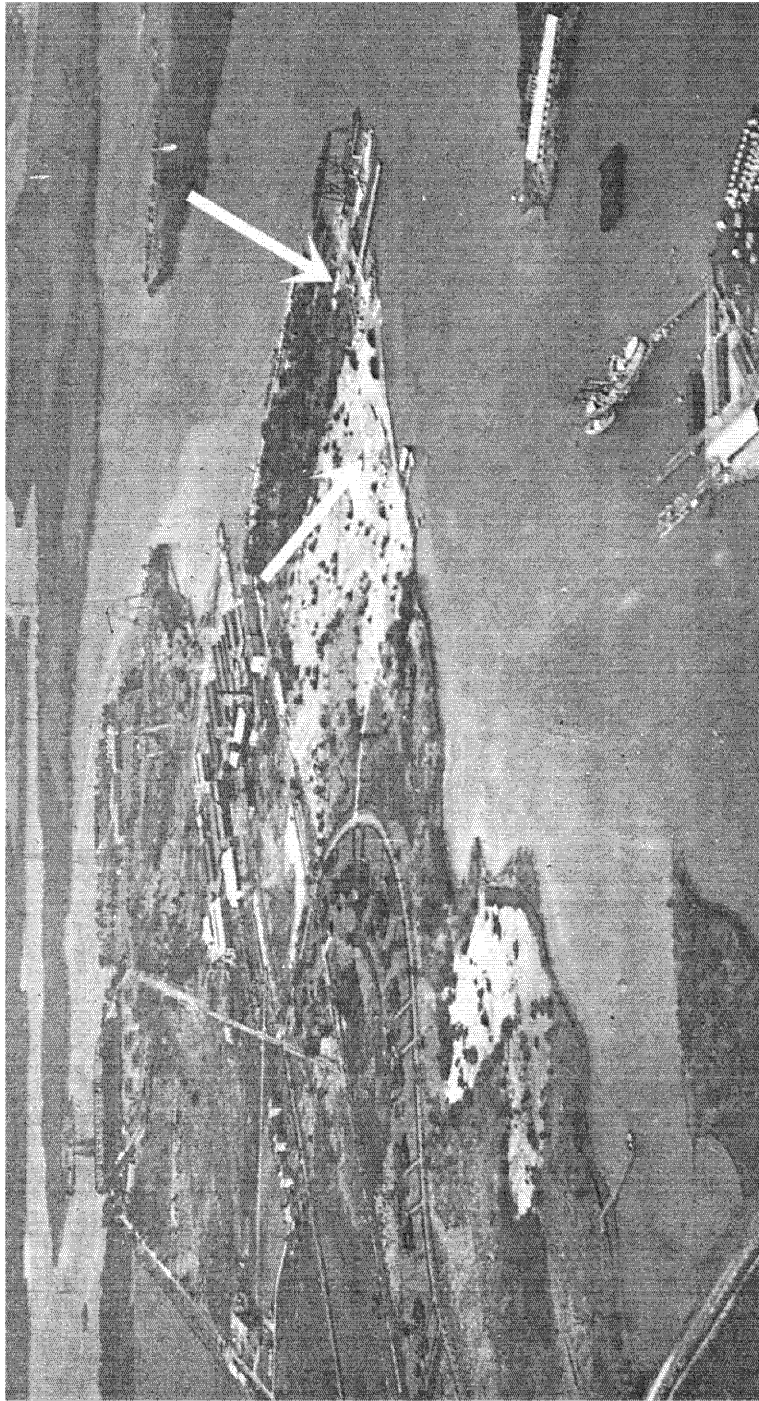
Portion of historic photo dated June 19, 1931 showing the beginning of dredging operations for the repair basins. Note the dredger (added arrow) at the harbor shoreline and the area of land to the left of it which will be removed. View facing north. From NARA II, 80 CF box 151, "PH # 16406."

During the early 1930s there was work for the dredges at Pearl Harbor. "In the first two years of the decade, the everlasting dredging of the entrance channel was continued, along with waterfront improvements".<sup>15</sup> This is when the dredging began at the site of the future repair basin area, in June 1931<sup>16</sup> after another round of much more extensive borings and soundings.<sup>17</sup>

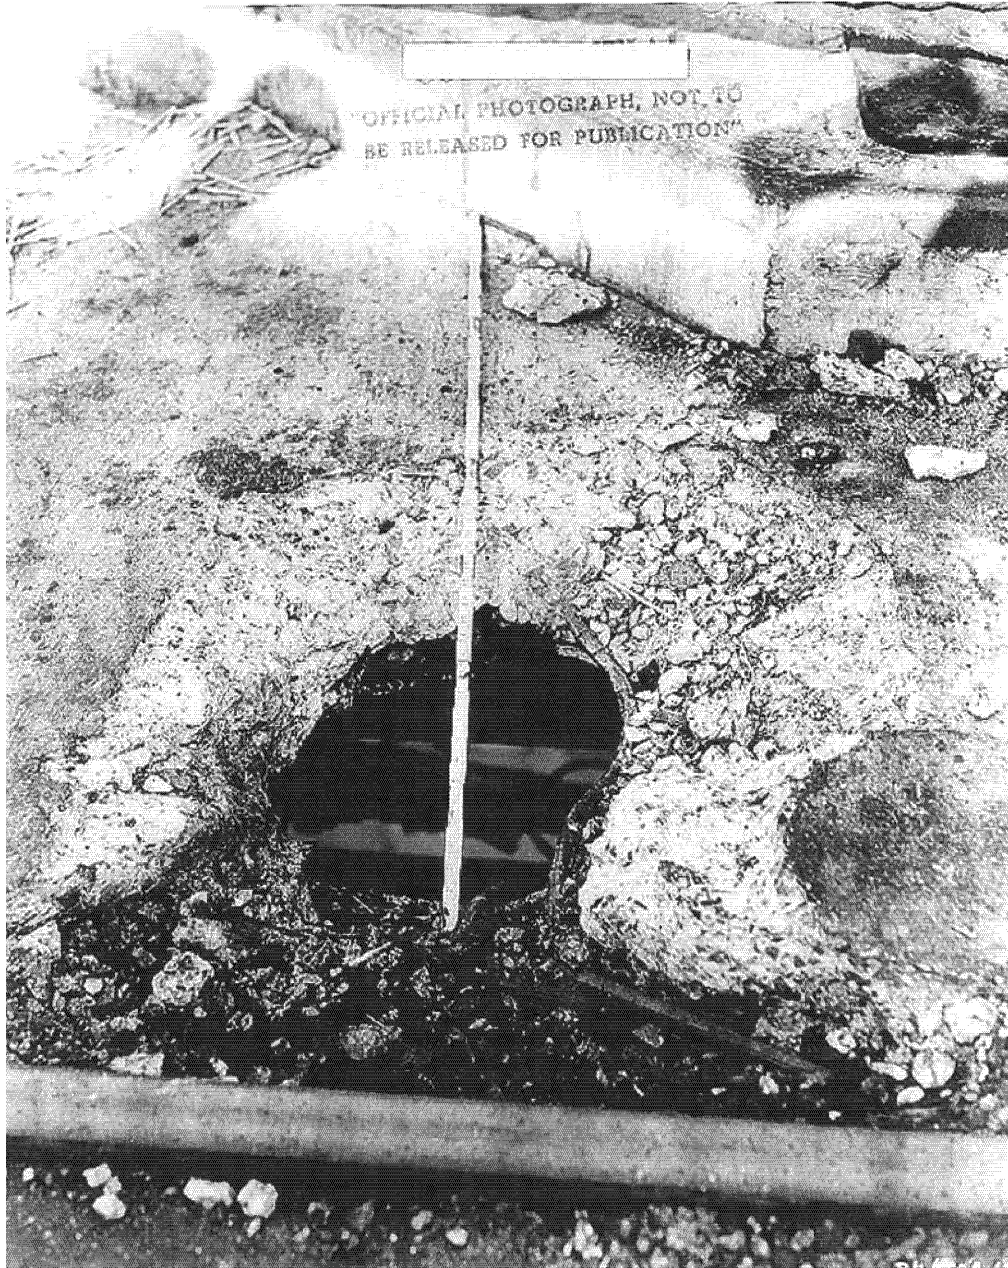
This sketch (ca. January 1942) shows the path of the Japanese bomb that passed through the concrete deck of B-21 and detonated near the USS *Honolulu*. Note the bomb trajectory at upper left. From Bureau of Ships, US Navy, website: [www.dcfp.navy.mil/cgi-bin/WarGallery](http://www.dcfp.navy.mil/cgi-bin/WarGallery) accessed on December 2, 2009

Several of the vessels moored at docks B-12 through B-21, as well as areas of the docks themselves were damaged during the attack. A bomb passed through the deck of wharf B-21, and detonated near the USS *Honolulu* which was moored there, damaging the ship near number 2 turret.<sup>30</sup> A plaque marking this bomb strike is set near the edge of the wharf, which reads:
